PHOTOGRAPHS

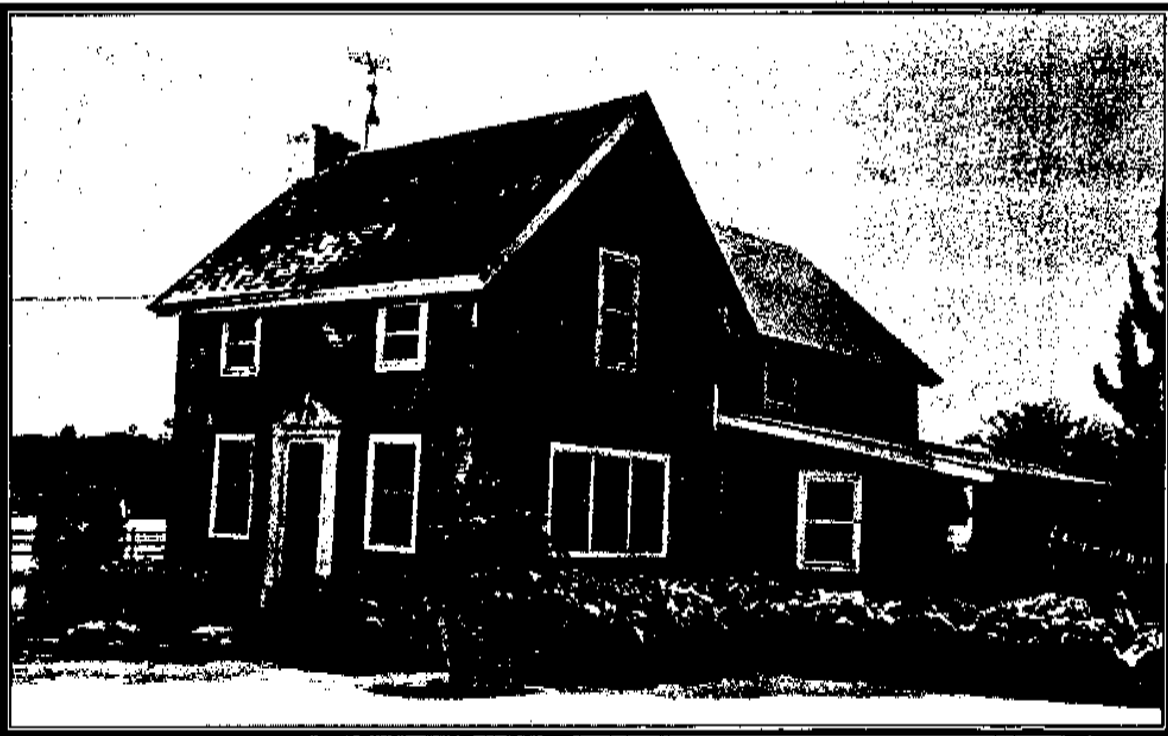
Photograph 77. S-11730, Jimtown, Resource S-942, former house located on the north side of Jimtown Road, facing east. Built ca. 1920 and located near Goslee Creek, the house is abandoned and has nearly collapsed.

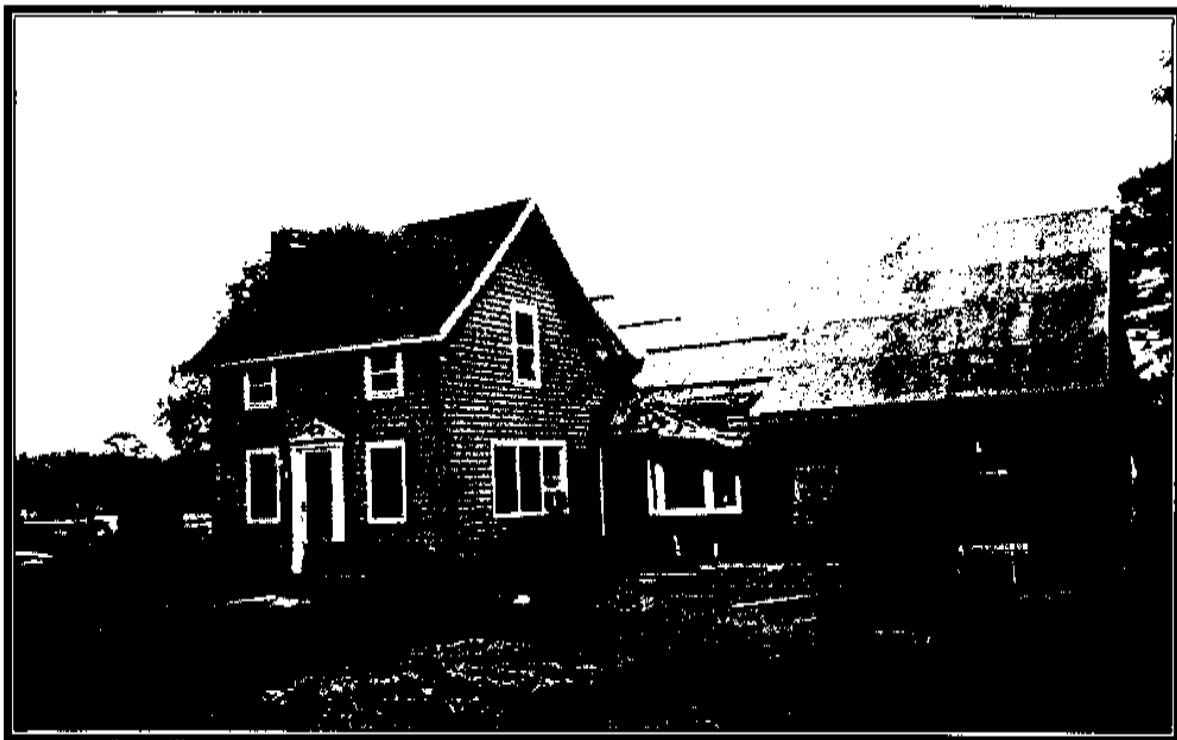
Photograph 78. S-947, Walls Farm, front (east) and north sides of the house as they appeared in December 2005, facing west. The larger portion of the original house extended to the north.

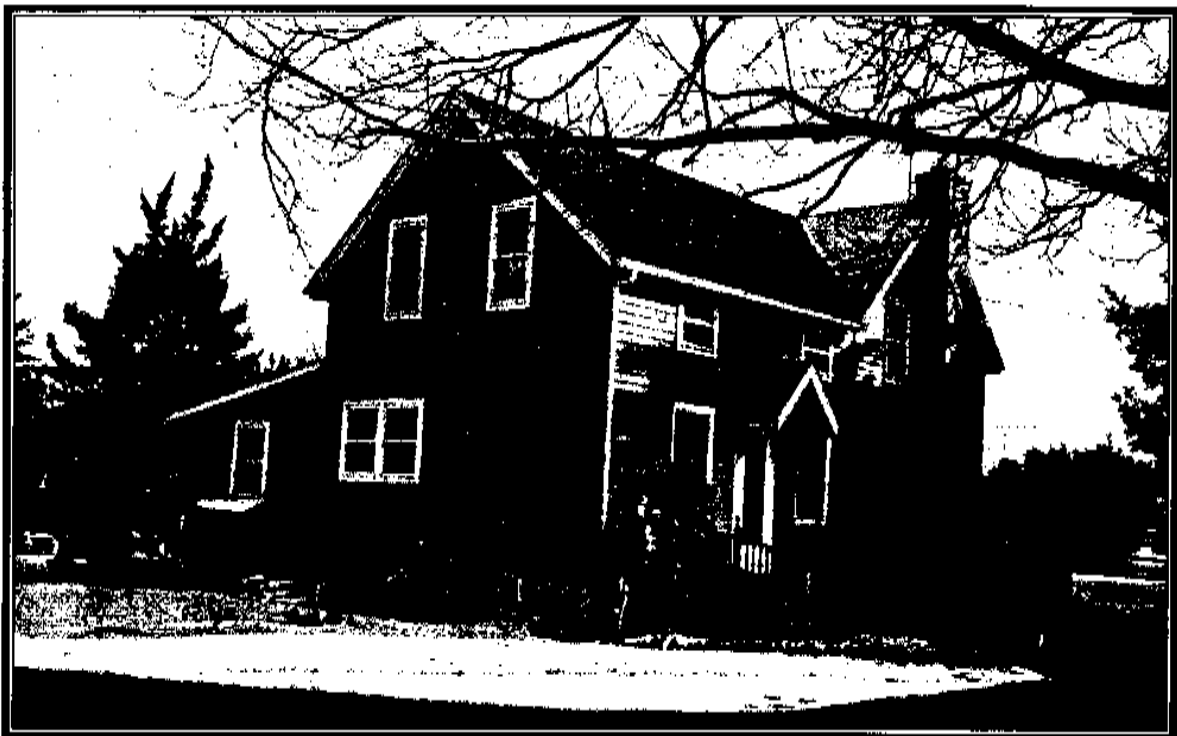
Photograph 79. S-947, Walls Farm, front (east) and north sides of the house with large addition under construction in September 2006, facing west.

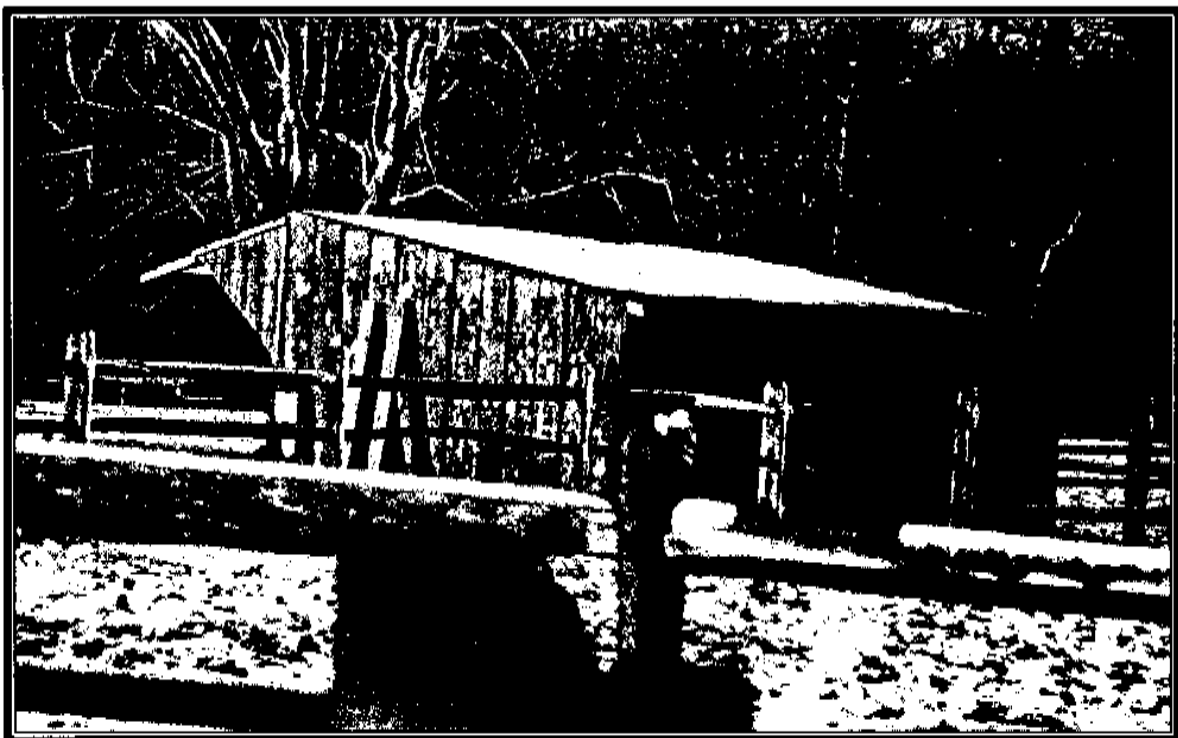
Photograph 82. S-947, Walls Farm, barn showing siding and large one-story addition to the north side, facing north.

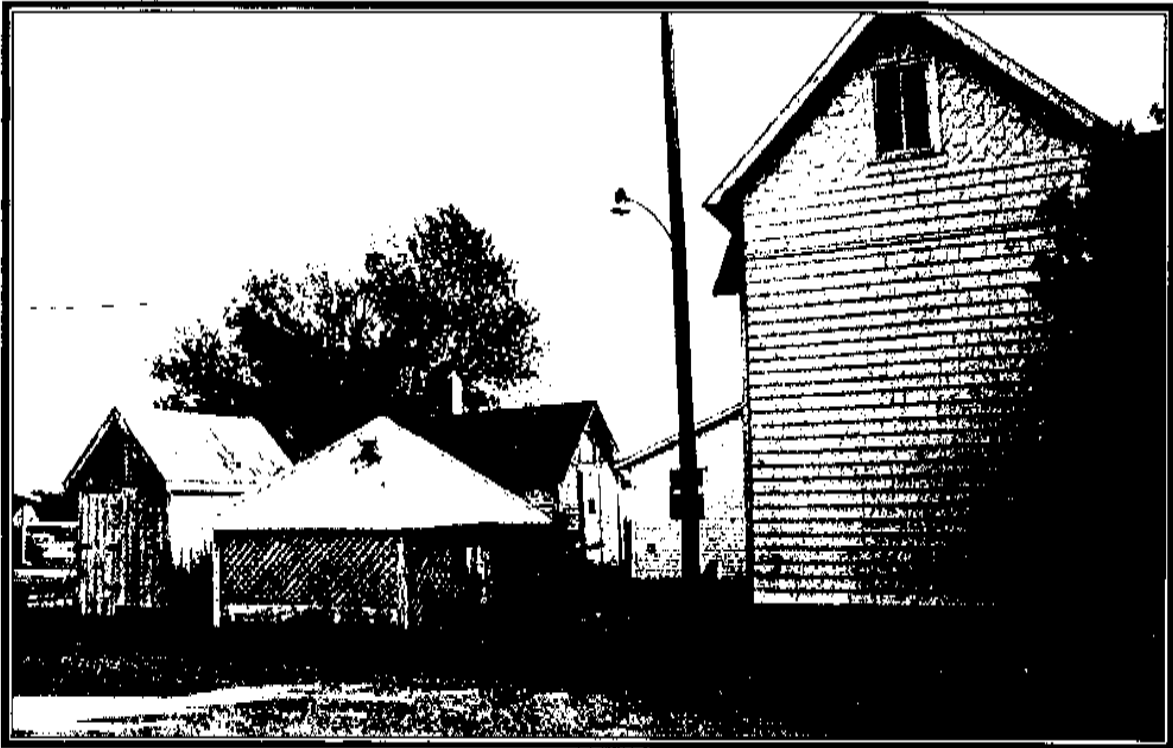
Photograph 86. S-951, Joseph Farm, remainder of the barn, facing north.
